# Crescent Lake

Klamath County  
Deschutes Basin

Location	
Area	4,547 acres (1,840.2 hect)
Elevation	4,839 ft (1,474.9 m)
Type	natural lake with dam
Use	irrigation, recreation
Location	29 mi southeast of Oakridge in Deschutes National Forest
Access	2 mi on paved road SW from Ore Hw y 58
USGS Quad	Odell Lake (24K), La Pine (100K)
Coordinates	43° 30' 05" N, 121° 58' 10" W
USPLSS	township 23S, range 06E, section 11

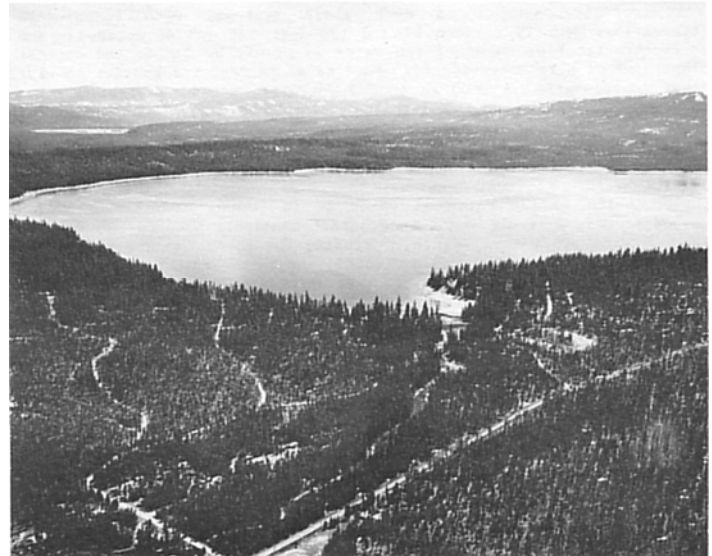
Source: US Bureau of Reclamation, 1970. View looking southwest.

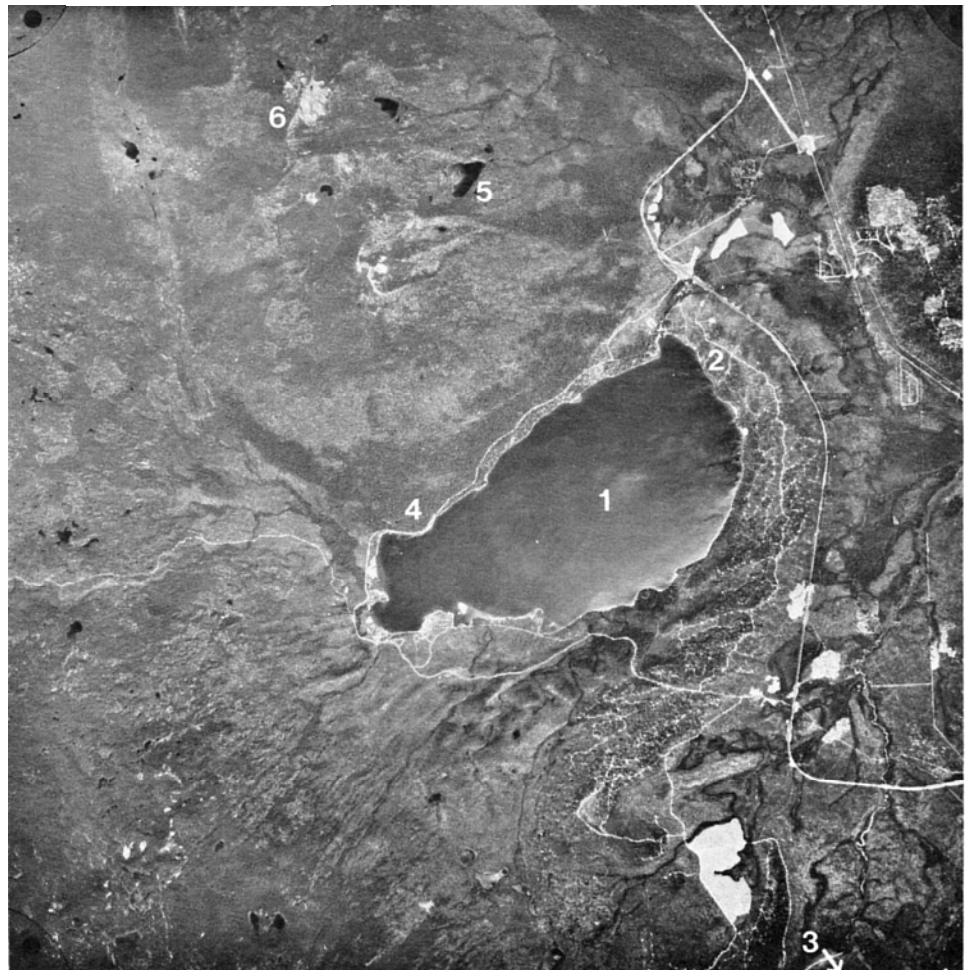
Source: US Forest Service, 1974. Vertical photograph.
