Devils Lake Lincoln County Mid Coast Basin

Lo	cation			
Area	678 acres (274.4 hect)		Elevation	20 ft (6.1 m)
Туре	natural lake	Use	recreation	
Location	eastern city limits of Lincoln	City;	east of US Hw y 101	
Access	several boat ramps - city, co	ounty	, and state	
USGS Quad	Lincoln City (24K), New port	(100	K)	
Coordinates	44° 58' 02" N, 124° 00' 51" V	٧		
USPLSS	tow nship 07, range 11, sec	tion '	15

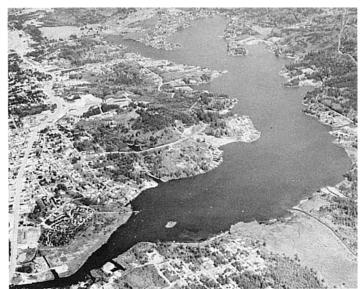
Source: US Geological Survey, no date. View looking north.
